Havarier, Hendelser Nye AD

Presentasjon for Teknisk Samling
05. – 07.02.2016

Geir Raudsandmoen

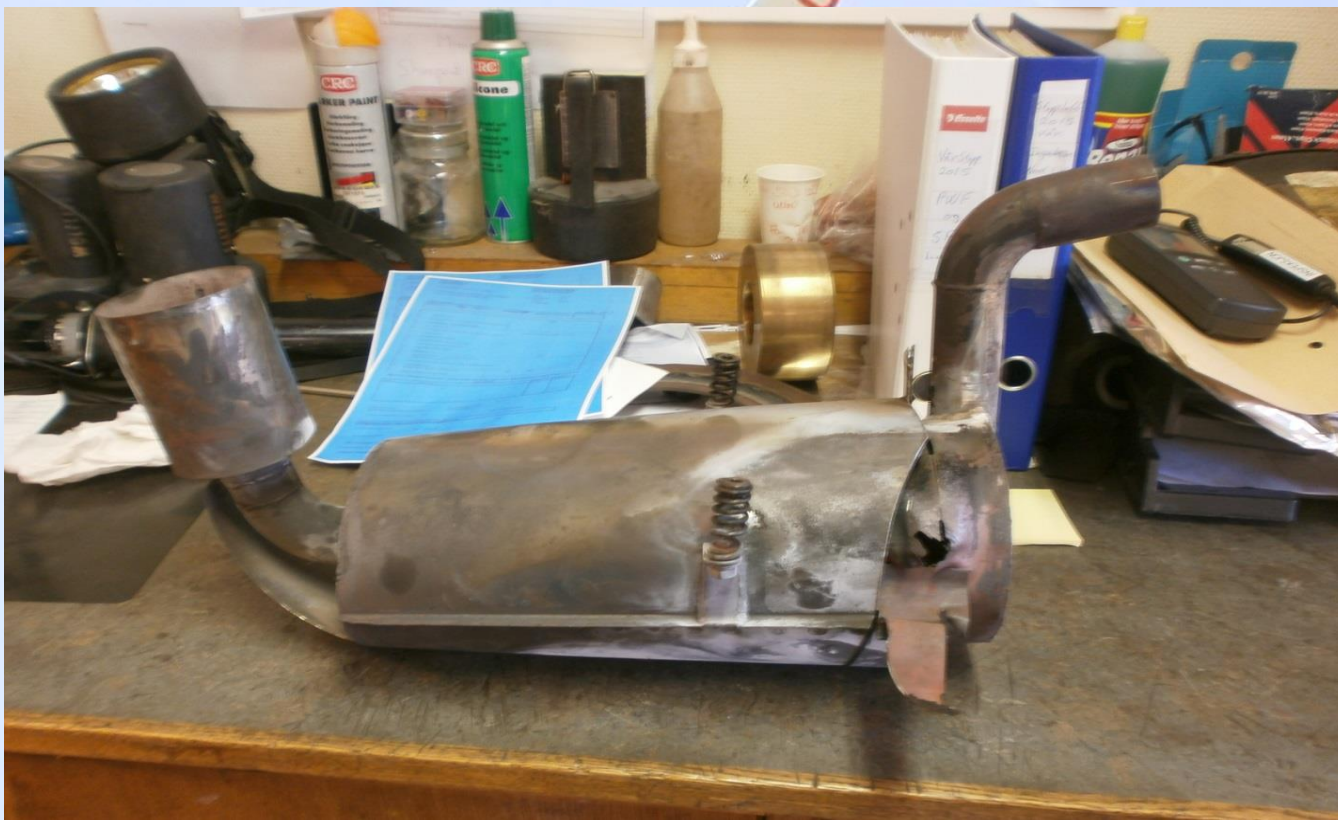
9/2015; Brann i smøreolje i motorrom p.g.a. sprekker i Wankel-motorens eksospotte, og lekkasje av varm eksosgass. SUK anbefaler umiddelbar lekkasjekontroll samt lekkasjekontroll ved utmontering for motoroverhaling (er det ofte nok?), samt montering av temperaturføler utenpå eksospotte (godkjent mod.?)
