Technical report

**Observation regarding construction feature of the Elevator Control System on Zlin
Aero Savage Classic in connection with investigation of fatal accident with microlight
aircraft LN-YWQ, 31 March 2014, Voss, Norway.**

Aircraft: Zlin Aero Savage Classic, S/N 237, LN-YWQ, manufactured 2012

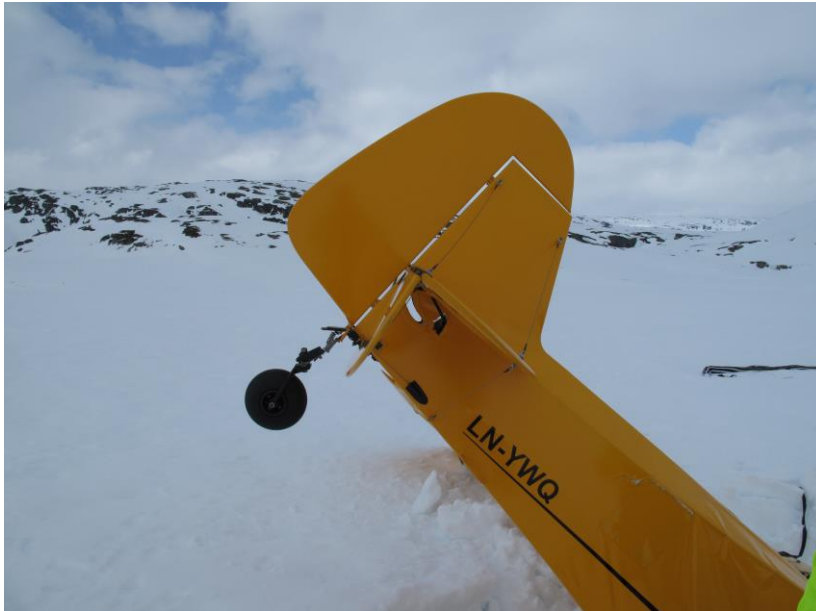
Position of the crashed aircraft nose down in the snow&ice surface

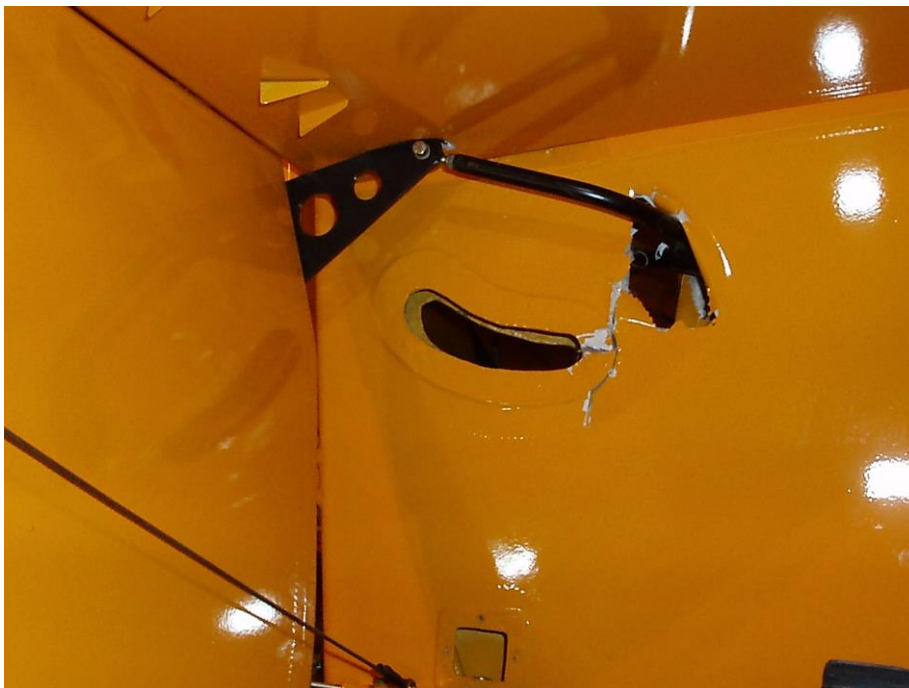
The Elevator Control Surface movement has no primary end stop on the control surface itself. If a sufficiently strong external force downward is applied to the Elevator surface it stops only against the lower cable rigging of the Horizontal Stabilizer.

In this situation the Elevator Control Horn and the Elevator Control Tube goes into a self-locking overcentre position. The Control Stick will then be locked in the extreme forward position. In this situation the more the pilot pulls the Stick, the more he locks and hold the control surface in the overcentre position.

Elevator Control Surface in the extreme down position due to crash impact forces. The elevator is overcentre and in a self-locking position.

This possibility would be eliminated by introducing a mechanical primary end stop on the control surface movement.

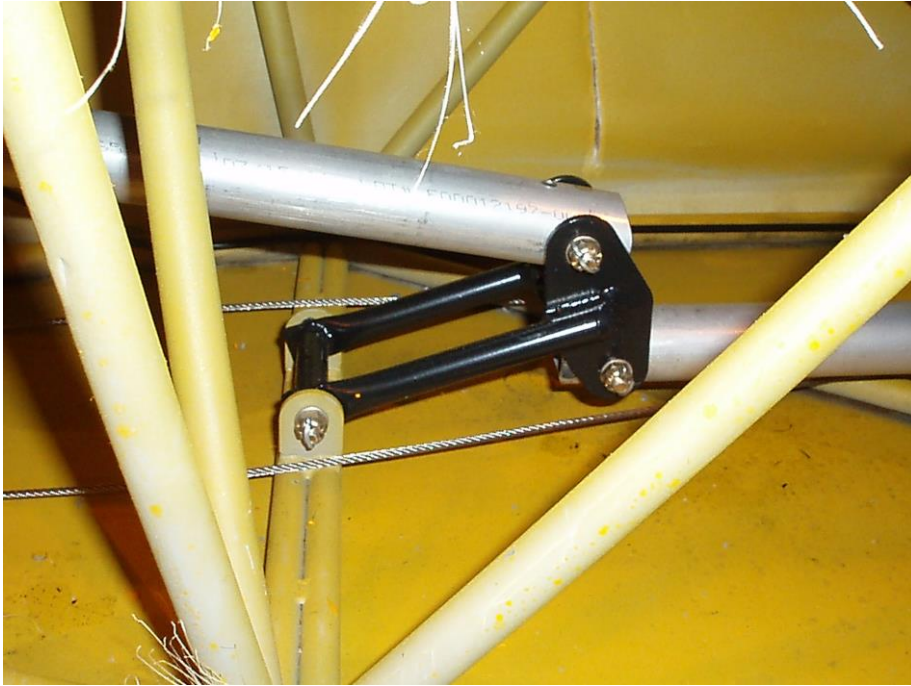
This is accentuated by the Walking Beam for the Elevator then being in the forward position (with the elevator control surface in the extreme down position). The walking Beam is almost overcentre and self-locked. A pulling force from the pilot gives no force further towards the elevator.

Walking Beam for the Elevator. This is in the forward position, that is how it is positioned with the elevator control surface in the extreme down position. The walking Beam is almost overcentre and self-locked. A pulling force from the pilot gives no force further towards the elevator.
